Washington's Landslide Blog

Lake Roosevelt Landslide/Seiche April 30, 2009

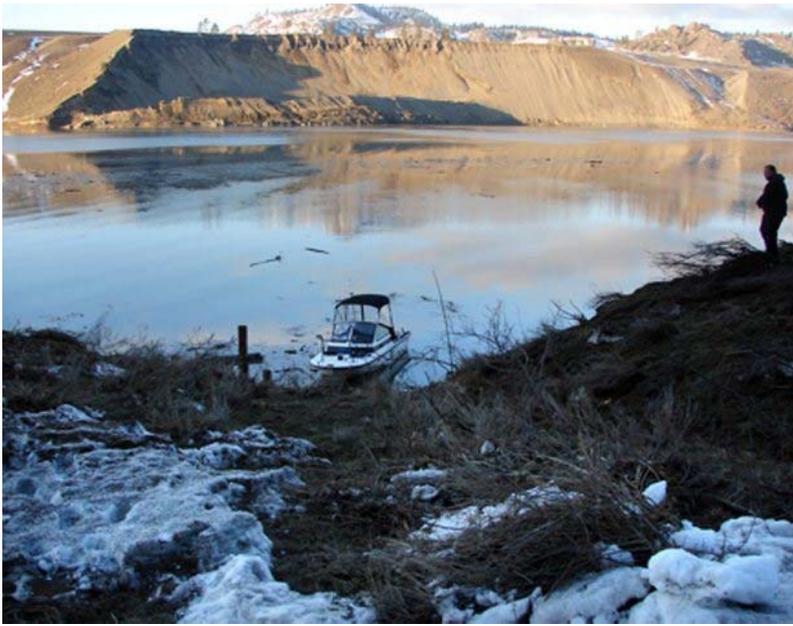
Lake Roosevelt Landslide?

“On Friday, January 16th, a large landslide occurred adjacent to the Spokane River near Mill Canyon. Homeowners in the Mill Canyon area contacted the park and reported that their docks had been destroyed by a large wave. Responding rangers found that a section of hillside measuring approximately 17 acres in size had broken free across from Breezy Bay and that the subsequent landslide had fallen into the water, creating a wave that was about 30 feet high when it hit the southern shore about a thousand yards across the lake. The wave damaged or destroyed several private docks located at Breezy Bay, Moccasin Bay, Sunset Point and Arrowhead Point. Several vessels moored in the area were also swamped and left beached on land. The water reached one residence before receding and came just to the foundations of several others. The full extent of the damage caused by the landslide is not yet known. Damage to property was documented as far as a mile and a half downstream, and significant resource damage and erosion to the shoreline occurred as far as three miles downstream. The park has issued a general safety warning due to the debris in the water, which is making navigation difficult. Boaters in the area have been advised to use extreme caution when boating from Cayuse Cove to Breezy Bay on the Spokane River. Along with ice deposits in the lake, there are now large trees, dead heads, dock parts, and unknown sediment deposits that have made safe navigation difficult. Due to unknown conditions near the slide, visitors are also being advised to avoid going on land at the site, as the ground will be quite unstable for some time and sinkholes and falling debris may occur. [Submitted by Adam Kelsey, Acting Chief Ranger]“

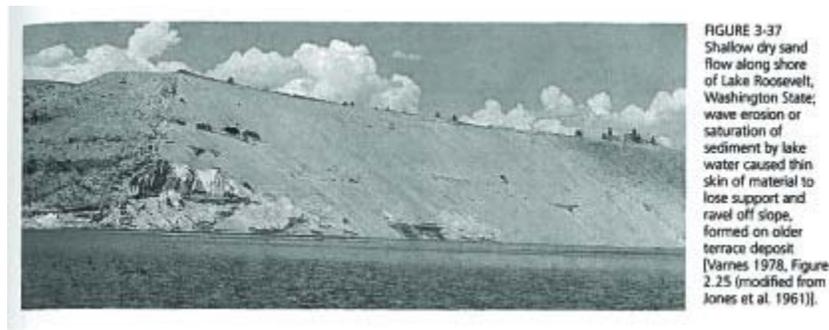
Lake Roosevelt Landslide - Cruden and Varnes

FIGURE 3-37
Shallow dry sand
flow along shore
of Lake Roosevelt,
Washington State;
wave erosion or
saturation of
sediment by lake
water caused thin
skin of material to
lose support and
ravel off slope,
formed on older
terrace deposit
[Varnes 1978, Figure
2.25 (modified from
Jones et al. 1961)].

This before photo clearly shows little debris at the base of the bluff. and gives an approximate idea of how large the landslide is in size.
